### Induron Paints Used to Rehabilitate Penn State Water Tanks

## Induron Paints Used to Rehabilitate Penn State Water Tanks (cont.)

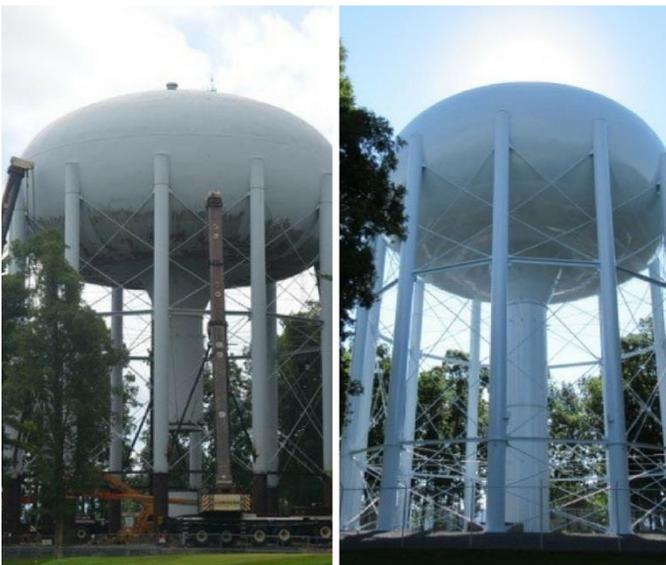
#### 1.5 MM Elevated Water Tank

Located in the center of the university's Blue Golf Course, the 1.5 MM elevated tank pictured below was the first of the 3 tank rehabilitation projects. Before repainting the tank, Phoenix Tank successfully raised the 12-legged tank by 16 feet. To prevent any contaminants from leaving the work area, the tank was shrouded with rigid containment throughout the construction process. Though 16 feet does not sound like much, this increased height will boost the water pressure in the area and improve the city's fire suppression capabilities. Induron is proud to be the preferred supplier of Corrosion Control Corporation (CCC) of New Jersey, who was contracted to paint the tank. Kent Webster, owner of CCC, acknowledged how pleased he was with Induron's products and services by sharing, "The projects we have done with Induron have all gone smoothly and with no call backs. Why wouldn't we want to use their products whenever we can?" All in all, thanks to the combined efforts of Project Services, CCC and MBA, this tank was successfully raised and repainted using Induron paints in September of 2016.

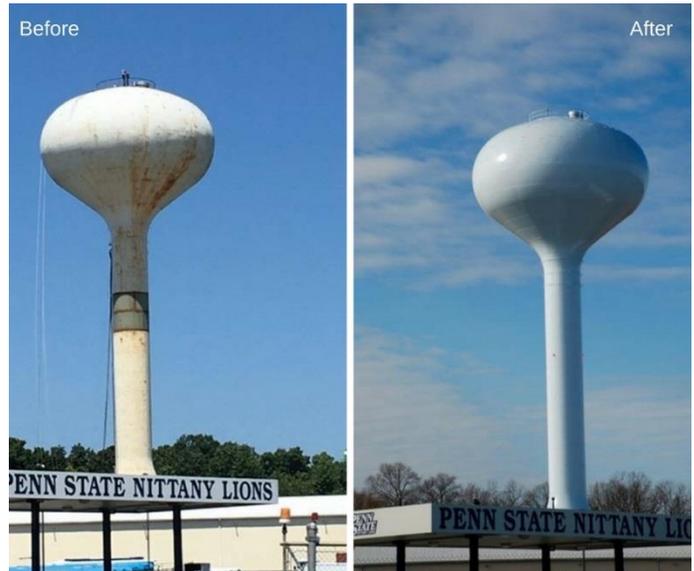
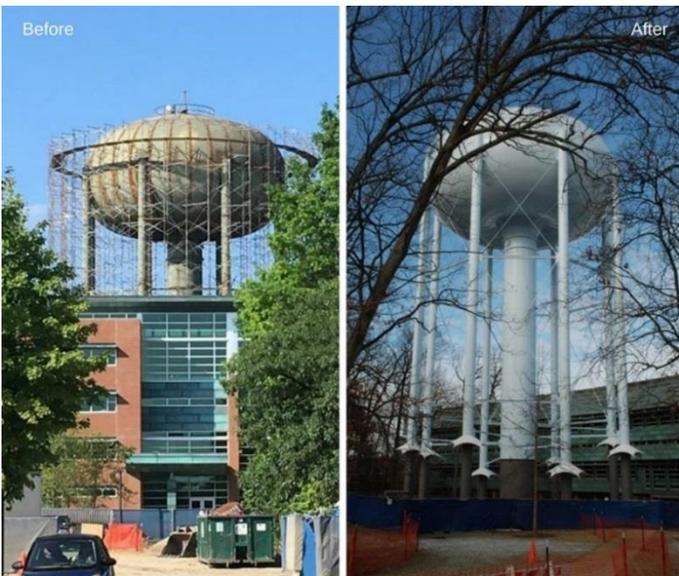
Last, but certainly not least, a 750 MM elevated water tank located at the center of Penn State's campus needed to be demolished, replaced and painted to complete the university's water improvement project. Because the tank was surrounded by university buildings, this rehabilitation project was especially difficult to execute and contain. However, it was made possible by shrouding the tank with rigid containment throughout the rehabilitation.

Caldwell Tanks tore down the existing tank, and then fabricated and erected the new tank pictured on the right. CCC painted the tank as a subcontractor to Caldwell Tanks. Now, the project just needs a new fill pipe to be completed! In the project photos below, you can see just how tight the construction site was that the contractors and painters dealt with.
