A Moldy, Mildewed Rose Isn't as Sweet

On August 7, 2000, Maguire Iron began erecting the new 250,000-gallon pedisphere water tank for the town, and it was quite a sight. It was a banner day for the city of Roseville, Illinois.

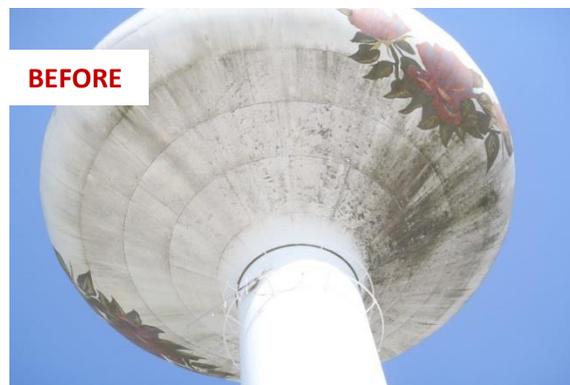
Once the money had been raised, Helen was told that the painting contractor had no rose design. Being an accomplished artist herself, Helen sent them a painting with a large rose in the center, a partially opened rose on one side and a rose bud on the other side. When spring arrived in April 2001, the rose was painted on Roseville's new water tower using her

designs. Helen helped supervise the painting, and she and her neighbors were all quite satisfied.

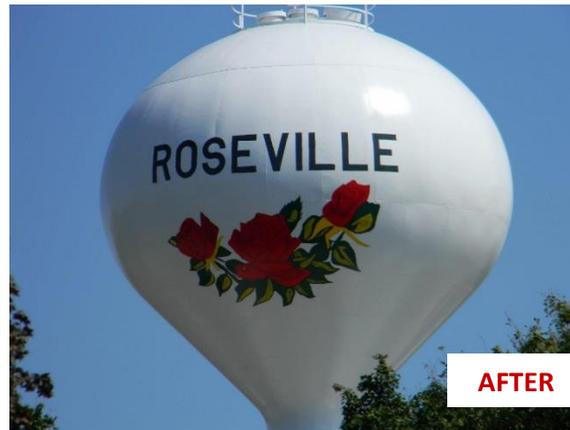
Unfortunately, as time passed, the rose faded....and was covered in mold and mildew.

In the spring of 2014, [Klingner Engineers](#) was contracted to perform maintenance on the 14-year-old tower. One of the items to accomplish was restoring the exterior of the tank and the rose to its former beauty. By this time, it was very faded and molded.

Induron was specified and selected as the supplier for the new coating. We recommended **Induron Permastic Polyurethane** for the exterior of the tank and **Perma-Gloss Fluorourethane** for the rose logo. Permastic Polyurethane, Perma-Gloss and all of Induron's urethane and fluorourethane finishes come with a factory added mildewcide

because we want our customers to have the very best. Perma-Gloss is the highest quality fluorourethane available to the protective coatings market.
