Case Study

250K Elevated Crownsville Hospital-Front Water Storage Tank Reconditioning

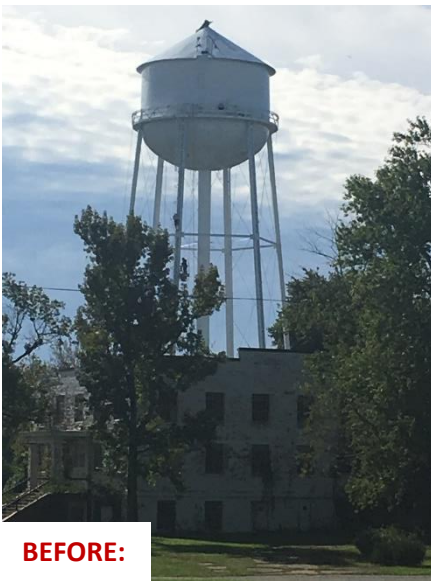
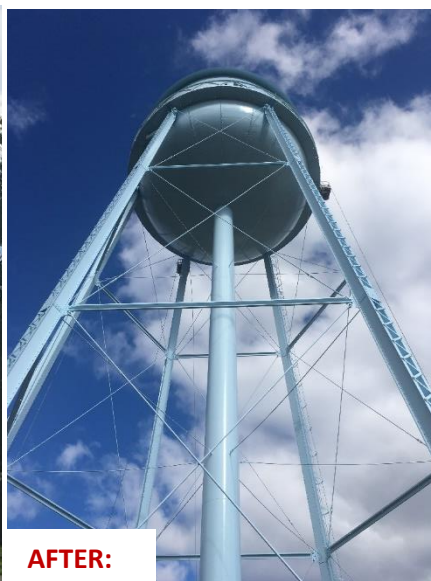
Maryland Environmental Service commented that Indurlux 9400 provides a wonderful gloss, and they are expecting the color and gloss to provide years of aesthetic value!

The interior system finish is a solvent-free, single-finish coat high-build system that reduces labor and offers maximum corrosion protection. The exterior system finish, [Indurlux 9400 Epoxy Siloxane](#), provides a polyurethane-like finish with exceptional weatherability, chemical resistance, gloss and color retention and contains no isocyanate. Indurlux 9400 is also available in almost any color. Both systems were compliant with Maryland VOC regulations, which are some of the nation's most stringent!
